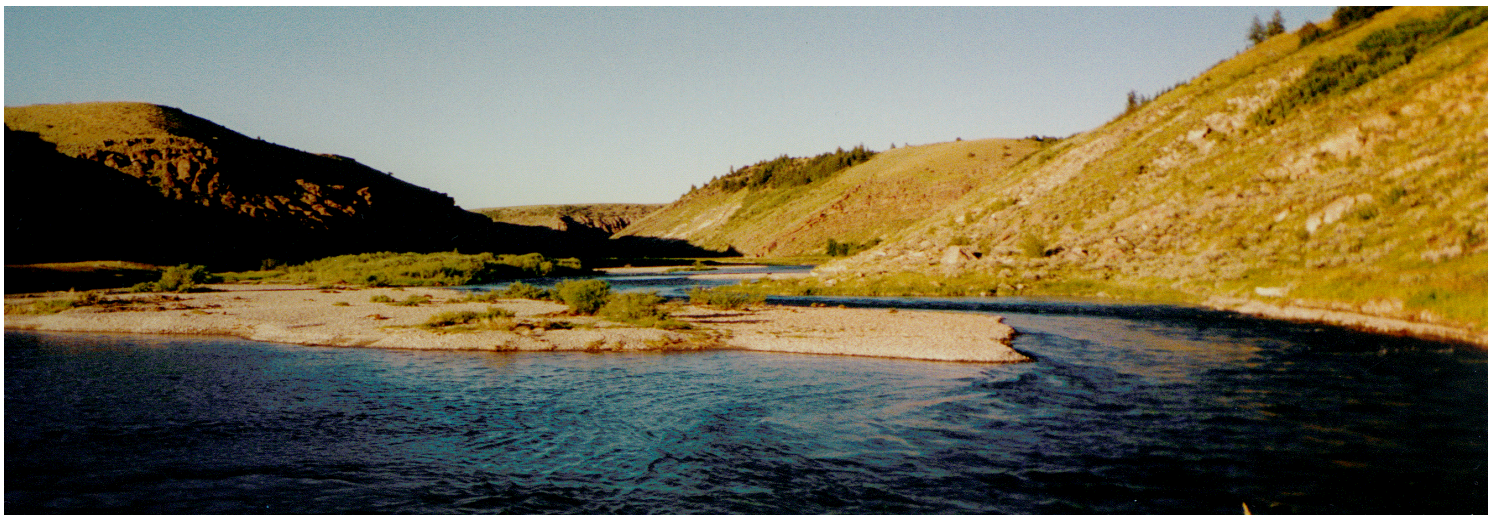
*Photograph A- 17. Looking upstream of the borrow ponds, the river naturally meanders between stream terraces and gravel bars. USBR photograph by Tim Randle, 1997.*

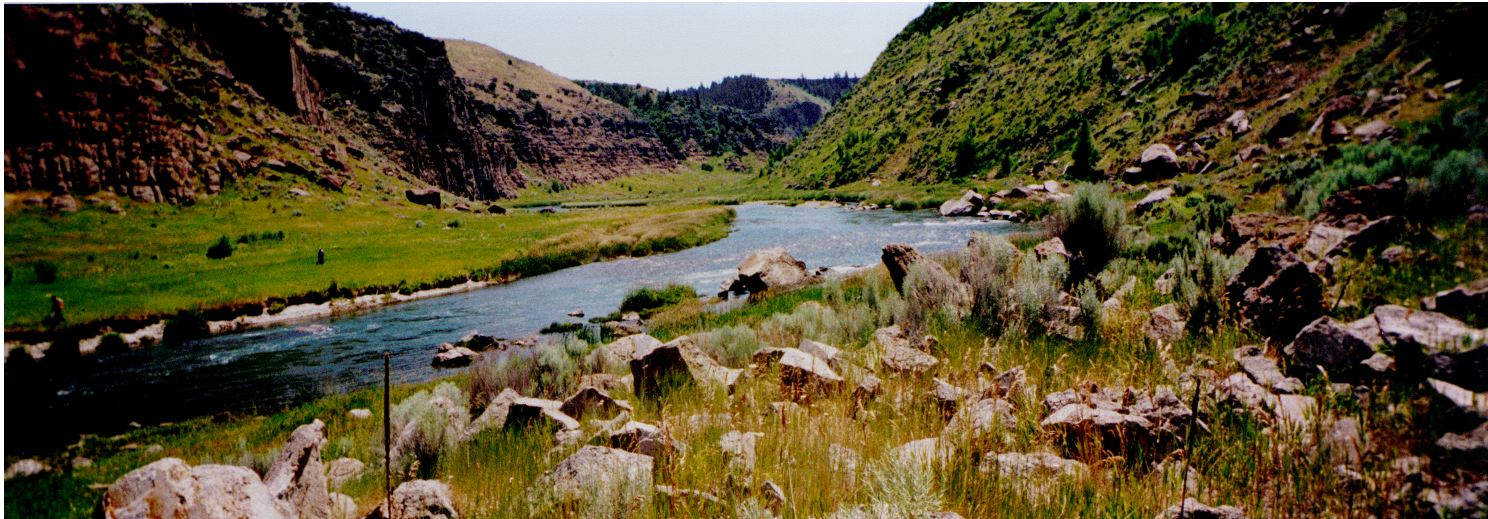
*Photograph A- 18. Four miles upstream of the dam site, the Teton River has wide flood plains along the north side (river right), landslide debris along the south side (river left), and flow that alternates between shallow pools and fast moving riffles. View is looking upstream. USBR photograph by Jennifer Bountry, 1998.*

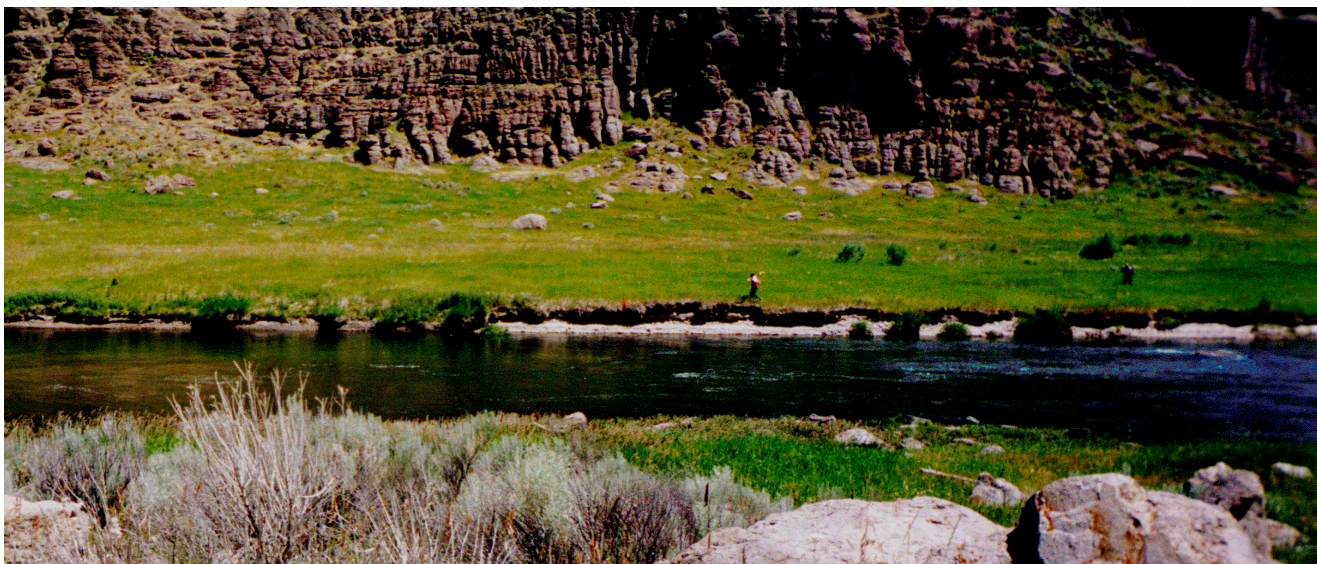
*Photograph A- 19. Along this reach, 4 miles upstream of the dam site, the river channel is being deflected by landslide material on the left bank and has begun to erode the right bank. USBR photograph by Jennifer Bountry, 1998.*

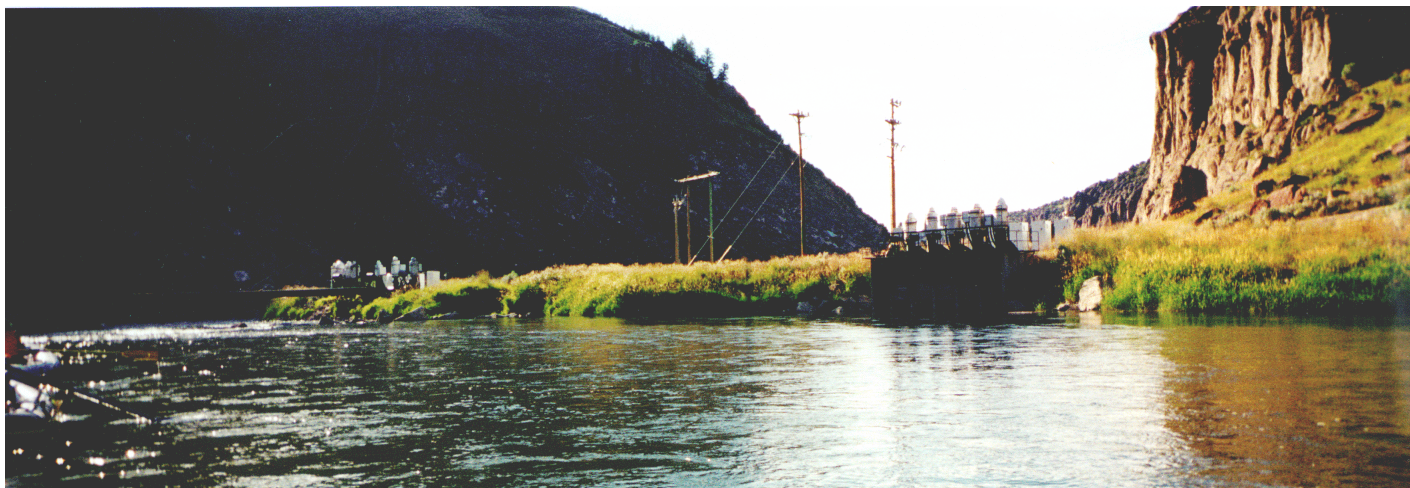
*Photograph A- 20. Just below Canyon Creek (about 4½ river miles upstream of the dam site), a pumping plant is located on the right bank of the river, and an irrigation pipeline crosses the river. USBR photograph by Tim Randle, 1997.*

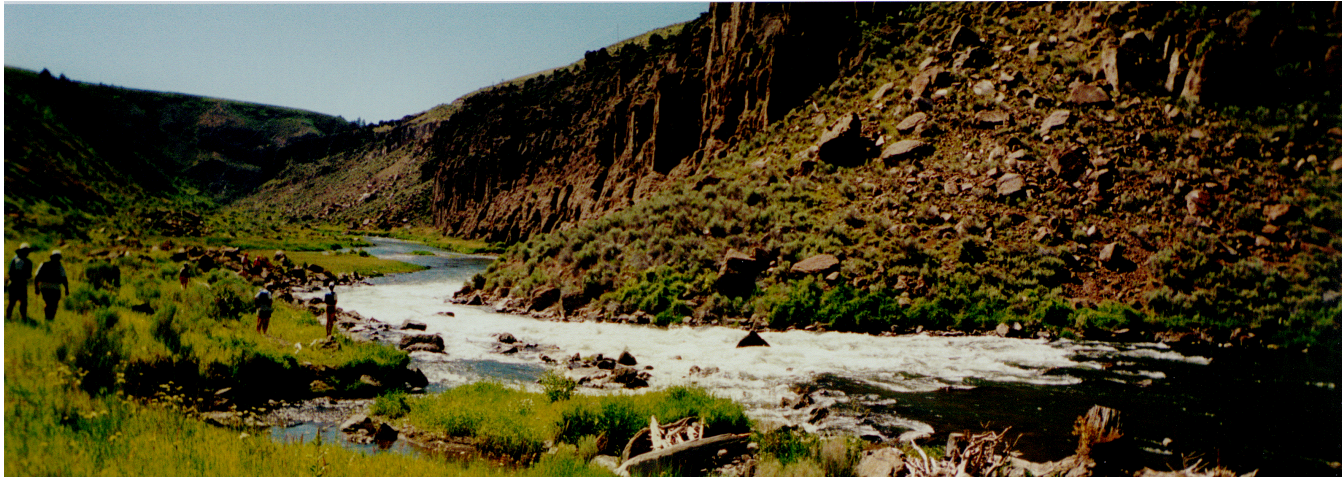
*Photograph A- 21. In the river reach between the confluence with Canyon Creek and the confluence with Bitch Creek (12 river miles of the former reservoir area), 27 pools and rapids were formed or enlarged by landslides from the filling and rapid drawdown of the Teton Reservoir in 1976. This is the largest rapid (rapid 27) located just upstream of Canyon Creek. This rapid is formed of landslide debris that came from the left canyon wall. The vertical elevation drop through this rapid is approximately 16 feet. USBR photograph by Tim Randle, 1997.*

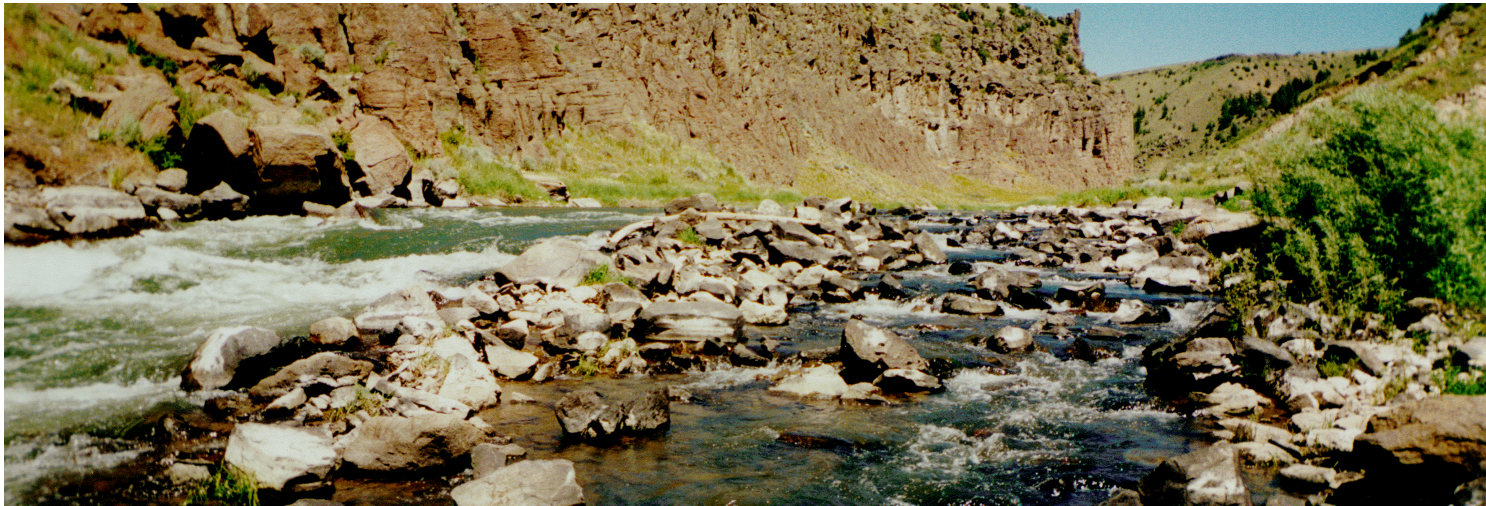
*Photograph A- 22. The particle size of landslide material forming rapid 27 varies from cobbles to large boulders. Much of the finer- grained material has been transported downstream. USBR photograph by Tim Randle, 1997.*
